TECHNICAL NOTE No: MECH. ENG. 261

CONTINUOUS-ROD WARHEAD LETHALITY
TRIALS AGAINST STATIC AIRCRAFT TARGETS
(RODS $\frac{1}{4}$ inch x $\frac{1}{4}$ inch CROSS-SECTION)

CONTINUOUS-ROD WARHEAD LETHALITY TRIALS AGAINST STATIC
AIRCRAFT TARGETS (RODS $\frac{1}{4}$ INCH \times $\frac{1}{4}$ INCH CROSS-SECTION)

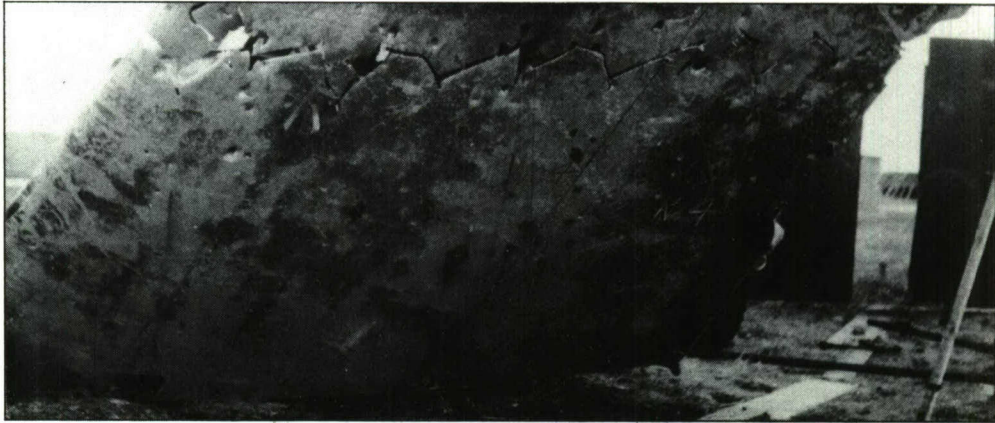
FIG.9a & 9b. VALIANT WING (Table 2; 2a)

FIG.9a. ROD ENTRY

FIG.9b. ROD EXIT

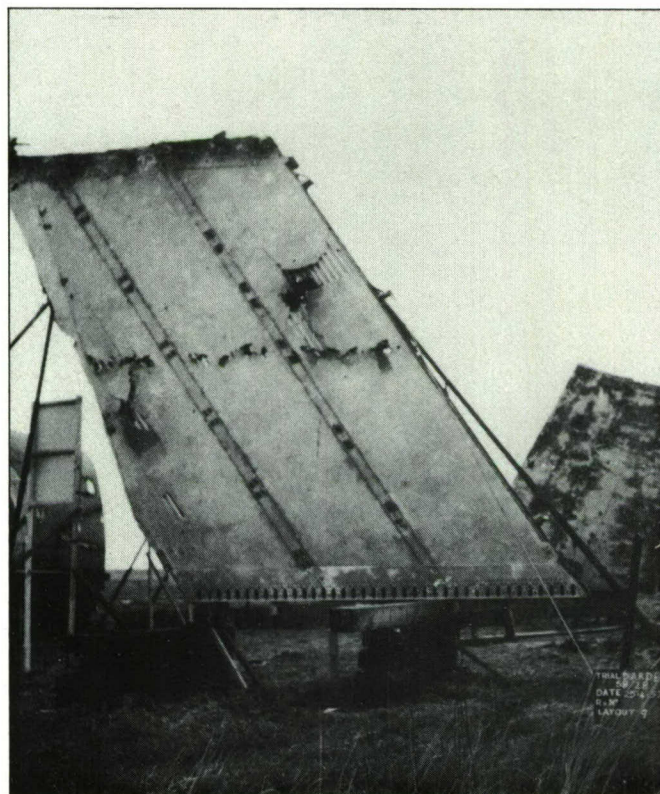
FIG.16a & 16b. VICTOR WING. (Table 2; 9a)

Target	Damage	A/C Kill Assessment
9 Victor A/C Wing		
(a) Target 3. Layout 3 Radius 25 ft. Impact at normal across upper surface.	Cut continuous across upper surface (10 ft). All stringers and spar upper booms (4 off) severed. Sandwich skinning on lower surface between spars severed (33, 36 and 33 in.) Four shatter cracks up to 2 ft long. (See Fig. 16)	100% A

FIG.16a. ROD ENTRY

FIG.16b. ROD EXIT
